**Flood Control Project Maintenance
Levee Inspections**
LMA District Cover Sheet
Spring 2017 Levee Inspection Results

Reclamation District No. 2068 Yolano

Spring 2017 Levee Inspection Results

Waterway			Bank	Unit Miles
Unit No. 01 Yolo Bypass			Right	5.48
	Spring (March - May)	Summer (June - August)	(September - November) Fall	Winter (December - February)
Unit Maintenance Rating (Fall Only)				
Date of Inspection	4/25/2017 - 4/25/2017			
DWR Inspector	Herman Phillips			
Accompanied By

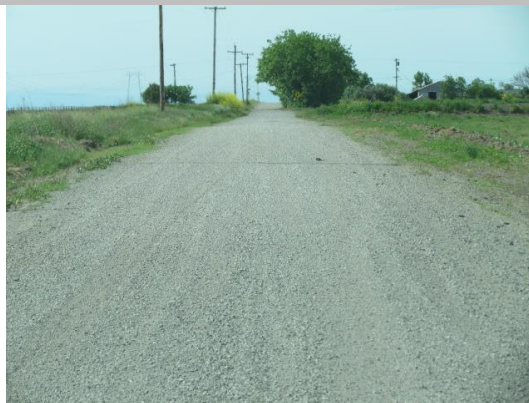
Photo 1 of 1 : SP_2017_RD2068_193_14_20170518_00015.jpg

LM Start	0.06	Rating **	A	Issue No.	14
LM End	0.45	Issue Type +	Ma	Location *	LS
Category	Earthen Levee			GPS Latitude/Longitude	
				Start	End
Item	Vegetation			38.407740 °	38.402073 °
				-121.693763 °	-121.693780 °
DWR ID	DWR_RD2068_01_s_2017_14				
Comment Code					
V1 : Control annual grass and weeds on the levee slopes and easements.					
Inspector Comment					
No unwanted vegetation on landside slope from 0.06 to 0.45.

RD 2068 Looking downstream from levee mile 0.06 landside.

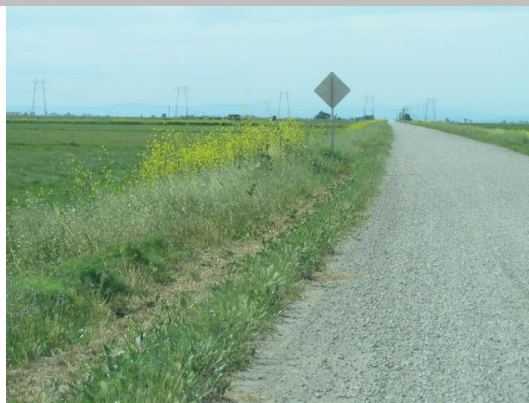
Photo 1 of 1 : SP_2017_RD2068_193_13_20170518_00016.jpg

LM Start	0.06	Rating **	M	Issue No.	13
LM End	0.50	Issue Type +	Ma	Location *	WS
Category	Earthen Levee			GPS Latitude/Longitude	
				Start	End
Item	Vegetation			38.407740 °	38.401318 °
				-121.693763 °	-121.693790 °
DWR ID	DWR_RD2068_01_s_2017_13				
Comment Code					
V1 : Control annual grass and weeds on the levee slopes and easements.					
Inspector Comment					
Control the annual grasses and weeds on the slope and toe.

Looking downstream from levee mile 0.06 landside shoulder.

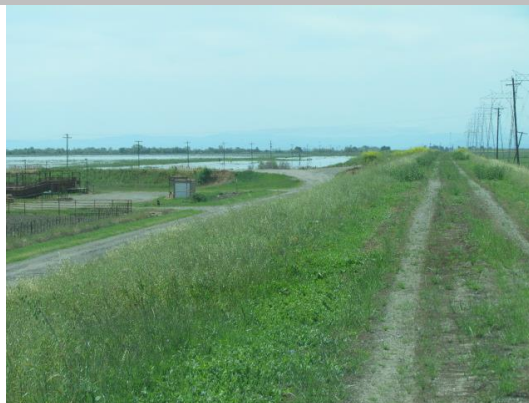
Photo 1 of 1 : SP_2017_RD2068_193_16_20170518_00017.jpg

LM Start	0.50	Rating **	U	Issue No.	16
LM End	5.48	Issue Type +	Ma	Location *	WS
Category	Earthen Levee			GPS Latitude/Longitude	
				Start	End
Item	Vegetation			38.401318 °	38.329110 °
				-121.693790 °	-121.694093 °
DWR ID	DWR_RD2068_01_s_2017_16				
Comment Code					
V1 : Control annual grass and weeds on the levee slopes and easements.					
Inspector Comment					
Control the annual grasses and weeds on the levee slope and toe waterside.

RD 2068 Looking downstream from levee mile 0.50-5.48 tall weeds present on the levee slope.

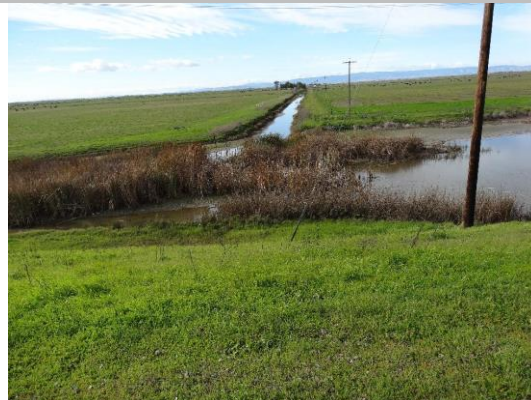
Photo 1 of 3 : UCIP_SP_2017_51451_76850.jpg

Comment Code					
Inspector Comment					
FS_ID:51451 DS_ID:19335 EP_NO: 7220 Repair Type: Non-Urgent Crossing Status: Indicator Found UCIP Comments: 12/06/2016 Line is abandoned according to a map obtained by the LMA. Gas line is labelled abandoned according to the map labelled "California Gas Transmission, Gas System Maintenance and Technical Support, Geographic Information Services", 5/10/2000 4:20 pm, City Solano, Division Sacramento, Zone 2, Wallmap #2-2649. Crossing has been downgraded from "Urgent" to "Non-Urgent" due to the supporting documentation provided by LMA to indicate gas line is abandoned. Need to contact owner to obtain as-builts for line abandonment. (O. Magana - DWR UCIP)08/08/2013 Pipe needs to have markers installed on both sides of levee. (W. Wylie - DWR UCIP) FIELD_STRUCT_DESC: 6.625-inch gas line of unknown material through the levee, 3 feet below the crown (Permit No. 7220, 1971 - Pacific Gas and Electric Company [PG&E]). [Additional Reference(s): DWR Levee Log, 1992]. FS Date: 12/6/2016

View of WS.

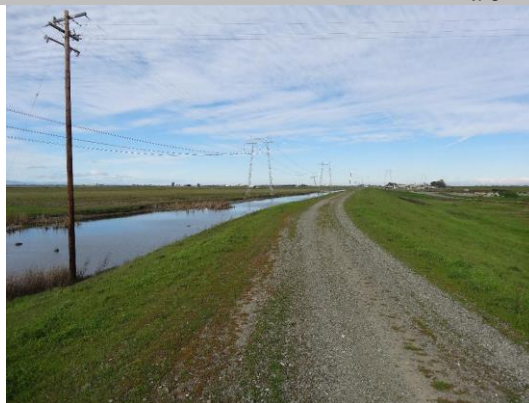
Photo 2 of 3 : UCIP_SP_2017_51451_76851.jpg

Comment Code					
Inspector Comment					
FS_ID:51451 DS_ID:19335 EP_NO: 7220 Repair Type: Non-Urgent Crossing Status: Indicator Found UCIP Comments: 12/06/2016 Line is abandoned according to a map obtained by the LMA. Gas line is labelled abandoned according to the map labelled "California Gas Transmission, Gas System Maintenance and Technical Support, Geographic Information Services", 5/10/2000 4:20 pm, City Solano, Division Sacramento, Zone 2, Wallmap #2-2649. Crossing has been downgraded from "Urgent" to "Non-Urgent" due to the supporting documentation provided by LMA to indicate gas line is abandoned. Need to contact owner to obtain as-builts for line abandonment. (O. Magana - DWR UCIP)08/08/2013 Pipe needs to have markers installed on both sides of levee. (W. Wylie - DWR UCIP) FIELD_STRUCT_DESC: 6.625-inch gas line of unknown material through the levee, 3 feet below the crown (Permit No. 7220, 1971 - Pacific Gas and Electric Company [PG&E]). [Additional Reference(s): DWR Levee Log, 1992]. FS Date: 12/6/2016

Overview of levee crown where crossing should be.

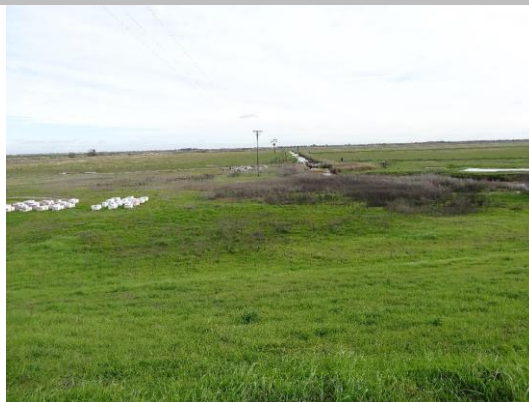
Photo 3 of 3 : UCIP_SP_2017_51451_76852.jpg

View of LS.

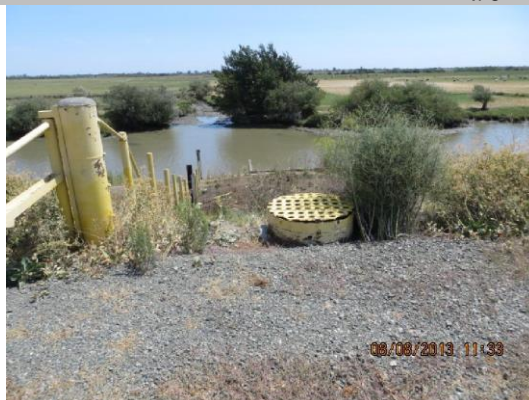
Photo 1 of 3 : UCIP_SP_2017_17479_29574.jpg

LM Start	5.46	Rating **	A/W	Issue No.	32
LM End	5.46	Issue Type +	Ma	Location *	CR
Category	Supplemental			GPS Latitude/Longitude	
				Start	End
Item	DWR UCIP LMA Responsibility			38.329410 °	38.329410 °
				-121.694076 °	-121.694076 °
DWR ID					
Comment Code					
Inspector Comment					
FS_ID:17479					
DS_ID:19343					
EP_NO: 2359					
Repair Type: No Action Needed					
Crossing Status: Found					
UCIP Comments:					
FIELD_STRUCT_DESC: 1 of 2: 36-inch steel drain pipe though the levee 3 feet below the crown. Siphon breaker in 36-inch diameter steel riser on WS shoulder. Flap gate in 10'X20' concrete outlet box at WS toe (Permit No. 2359, 1957). Included in O&M manual, 1962.					
FS Date: 8/8/2013

Siphon breaker in 36-inch diameter steel riser on WS shoulder.

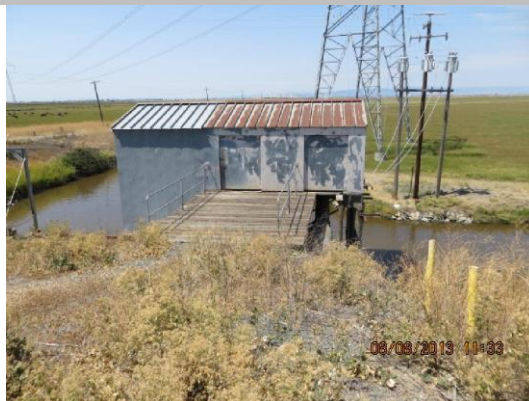
Photo 2 of 3 : UCIP_SP_2017_17479_29573.jpg

Pumphouse visible on pier at LS.

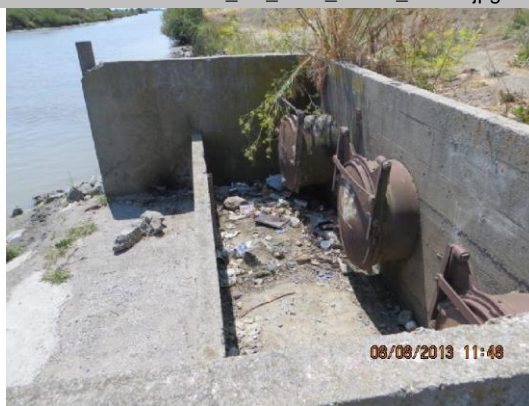
Photo 3 of 3 : UCIP_SP_2017_17479_29572.jpg

LM Start	5.46	Rating **	A/W	Issue No.	32 (cont)					
LM End	5.46	Issue Type +	Ma	Location *	CR					
Category	Supplemental		GPS Latitude/Longitude							
			Start	End						
Item	DWR UCIP LMA Responsibility		38.329410 °	38.329410 °						
			-121.694076 °	-121.694076 °						
DWR ID										
Comment Code										
Inspector Comment										
FS_ID:17479 DS_ID:19343 EP_NO: 2359 Repair Type: No Action Needed Crossing Status: Found UCIP Comments: FIELD_STRUCT_DESC: 1 of 2: 36-inch steel drain pipe though the levee 3 feet below the crown. Siphon breaker in 36-inch diameter steel riser on WS shoulder. Flap gate in 10'X20' concrete outlet box at WS toe (Permit No. 2359, 1957). Included in O&M manual, 1962. FS Date: 8/8/2013

Flap gate in 10'X20' concrete outlet box at WS toe.

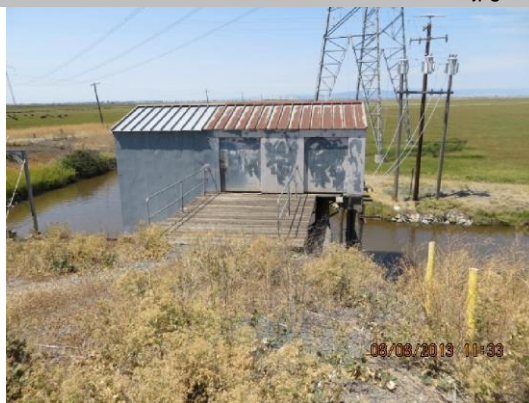
Photo 1 of 3 : UCIP_SP_2017_17480_29578.jpg

LM Start	5.46	Rating **	A/W	Issue No.	33					
LM End	5.46	Issue Type +	Ma	Location *	CR					
Category	Supplemental		GPS Latitude/Longitude							
			Start	End						
Item	DWR UCIP LMA Responsibility		38.329397 °	38.329397 °						
			-121.694076 °	-121.694076 °						
DWR ID										
Comment Code										
Inspector Comment										
FS_ID:17480 DS_ID:19342 EP_NO: 2359 Repair Type: No Action Needed Crossing Status: Found UCIP Comments: FIELD_STRUCT_DESC: 2 of 2: 42-inch steel drain pipe though the levee 3 feet below the crown. Siphon breaker in 36-inch steel riser on WS shoulder. Flap gate in 10'X20' concrete outlet box at WS toe. Pump in pumphouse on pier at LS (Permit No. 2359, 1957). Included in O&M manual, 1962. FS Date: 8/8/2013

Pump in pumphouse on pier at LS.

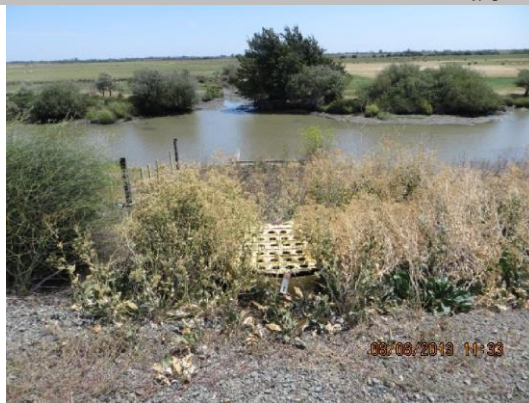
Photo 2 of 3 : UCIP_SP_2017_17480_29577.jpg

LM Start	5.46	Rating **	A/W	Issue No.	33 (cont)
LM End	5.46	Issue Type +	Ma	Location *	CR
Category	Supplemental			GPS Latitude/Longitude	
				Start	End
Item	DWR UCIP LMA Responsibility			38.329397°	38.329397°
				-121.694076°	-121.694076°
DWR ID					
Comment Code					
Inspector Comment					
FS_ID:17480					
DS_ID:19342					
EP_NO: 2359					
Repair Type: No Action Needed					
Crossing Status: Found					
UCIP Comments:					
FIELD_STRUCT_DESC: 2 of 2: 42-inch steel drain pipe though the levee 3 feet below the crown. Siphon breaker in 36-inch steel riser on WS shoulder. Flap gate in 10'X20' concrete outlet box at WS toe. Pump in pumphouse on pier at LS (Permit No. 2359, 1957). Included in O&M manual, 1962.					
FS Date: 8/8/2013

Siphon breaker in 36-inch steel riser on WS shoulder.

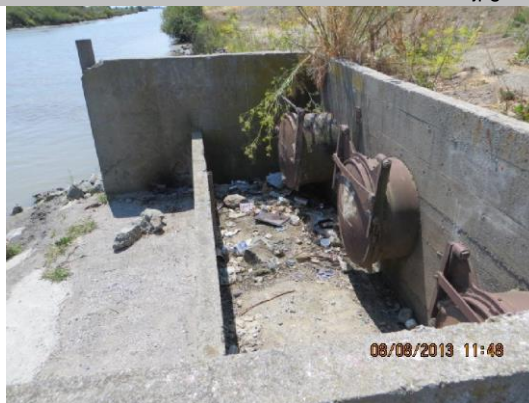
Photo 3 of 3 : UCIP_SP_2017_17480_29576.jpg

Flap gate in 10'X20' concrete outlet box at WS toe.

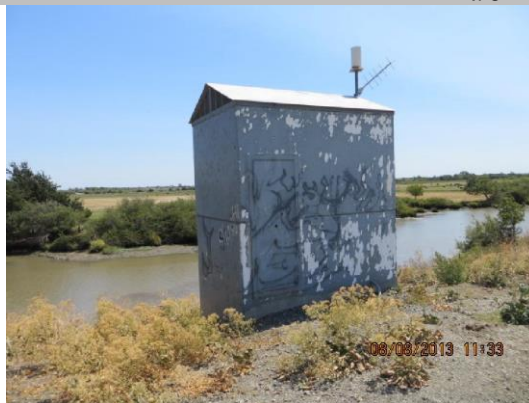
Photo 1 of 3 : UCIP_SP_2017_17503_29587.jpg

LM Start	5.47	Rating **	A/W	Issue No.	34
LM End	5.47	Issue Type +	Ma	Location *	CR
Category	Supplemental			GPS Latitude/Longitude	
				Start	End
Item	DWR UCIP LMA Responsibility			38.329275 °	38.329275 °
				-121.694078 °	-121.694078 °
DWR ID					
Comment Code					
Inspector Comment					
FS_ID:17503 DS_ID:19340 EP_NO: 15923 Repair Type: No Action Needed Crossing Status: Found UCIP Comments: FIELD_STRUCT_DESC: 6'x6' Reinforced concrete box culvert through the levee 21.1 feet below the crown. 9'X14' concrete inlet/weir on LS toe. 7'X10' concrete building houses Slide gate on WS shoulder Flap gate in 8'X10' concrete U-shaped headwall on WS toe. (Permit No. 15923, 1992). Culvert replaced three 36-inch pipes installed under Permit No. 10160, 1974. FS Date: 8/8/2013

Slide gate in concrete building on WS shoulder.

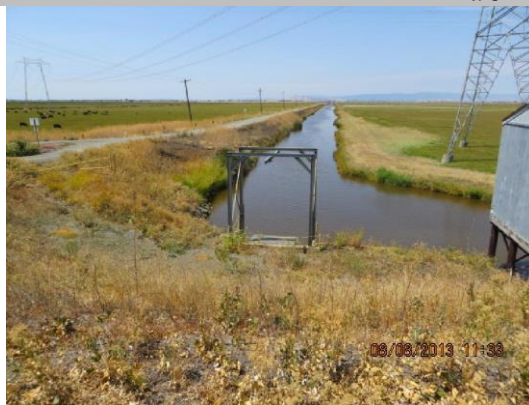
Photo 2 of 3 : UCIP_SP_2017_17503_29586.jpg

Concrete inlet/weir on LS toe.

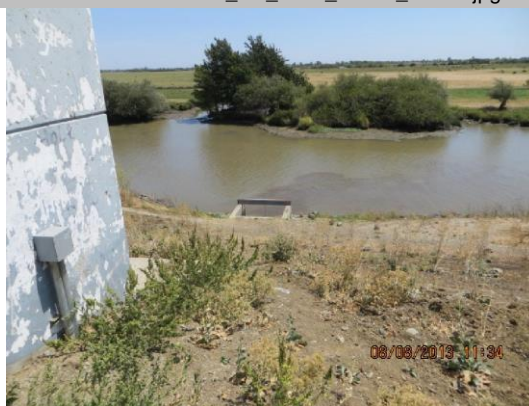
Photo 3 of 3 : UCIP_SP_2017_17503_29585.jpg

LM Start	5.47	Rating **	A/W	Issue No.	34 (cont)	
LM End	5.47	Issue Type +	Ma	Location *	CR	
Category	Supplemental			GPS Latitude/Longitude		
				Start		End
Item	DWR UCIP LMA Responsibility			38.329275 °	38.329275 °	
				-121.694078 °	-121.694078 °	
DWR ID						
Comment Code						
Inspector Comment						
FS_ID:17503 DS_ID:19340 EP_NO: 15923 Repair Type: No Action Needed Crossing Status: Found UCIP Comments: FIELD_STRUCT_DESC: 6'x6' Reinforced concrete box culvert through the levee 21.1 feet below the crown. 9'X14' concrete inlet/weir on LS toe. 7'X10' concrete building houses Slide gate on WS shoulder Flap gate in 8'X10' concrete U-shaped headwall on WS toe. (Permit No. 15923, 1992). Culvert replaced three 36-inch pipes installed under Permit No. 10160, 1974. FS Date: 8/8/2013

Flap gate in concrete outlet on WS toe.

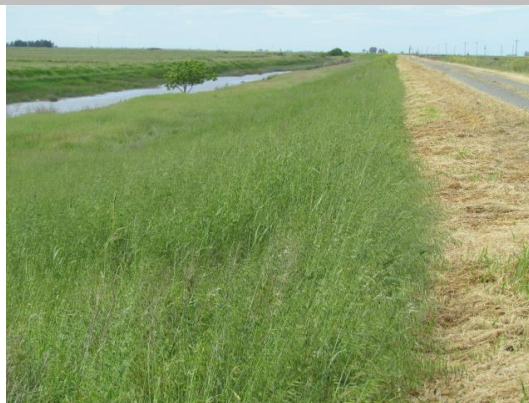
Photo 1 of 1 : SP_2017_RD2068_194_10_20170518_00008.jpg

LM Start	0.01	Rating **	U	Issue No.	10
LM End	0.93	Issue Type +	Ma	Location *	LS
Category	Earthen Levee			GPS Latitude/Longitude	
				Start	End
Item	Vegetation			38.358227 °	38.371688 °
				-121.740365 °	-121.740033 °
DWR ID	DWR_RD2068_02_s_2017_10				
Comment Code					
V1 : Control annual grass and weeds on the levee slopes and easements.					
Inspector Comment					
Control the annual grasses and weeds on the landside slope and berm.

RD 2068 Looking downstream landside slope and berm.

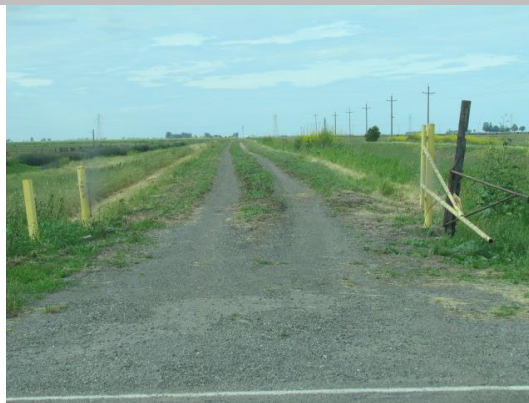
Photo 1 of 1 : SP_2017_RD2068_194_11_20170518_00009.jpg

LM Start	0.01	Rating **	M	Issue No.	11
LM End	1.85	Issue Type +	Ma	Location *	CR
Category	Earthen Levee			GPS Latitude/Longitude	
				Start	End
Item	Vegetation			38.358313 °	38.382542 °
				-121.740385 °	-121.730262 °
DWR ID	DWR_RD2068_02_s_2017_11				
Comment Code					
V9 : Keep the crown roadway free of vegetation.					
Inspector Comment					
Keep crown roadway free of vegetation.

RD 2068 Looking downstream from levee mile 0.01.

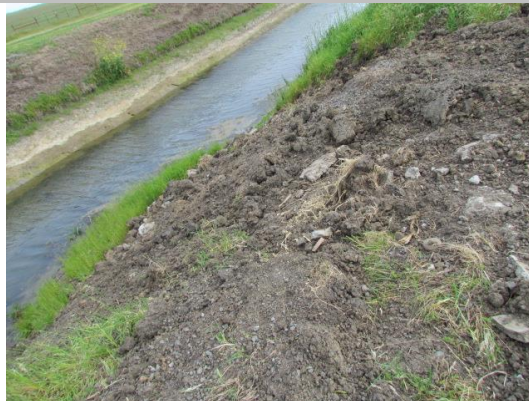
Photo 1 of 1 : SP_2017_RD2068_194_14_20170518_00010.jpg

LM Start	0.65	Rating **	M	Issue No.	14
LM End	0.65	Issue Type +	Ma	Location *	LS
Category	Earthen Levee			GPS Latitude/Longitude	
				Start	End
Item	Slope Stability			38.367547 °	38.367547 °
				-121.740273 °	-121.740273 °
DWR ID	DWR_RD2068_02_s_2017_14				
Comment Code					
S1 : Repair slope instability.					
Inspector Comment					
RD has made repairs to slip.

RD 2068 Slope instability 0.65 waterside slope.

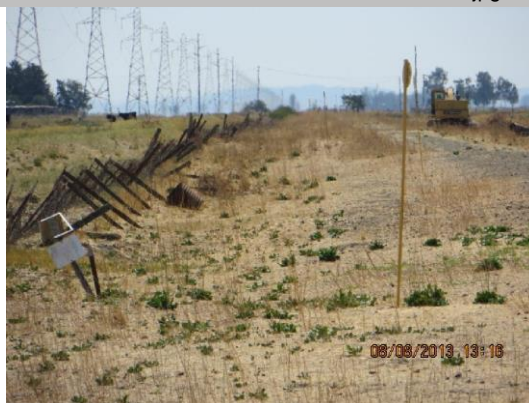
Photo 1 of 2 : UCIP_SP_2017_17531_29641.jpg

LM Start	0.91	Rating **	M	Issue No.	23					
LM End	0.91	Issue Type +	En	Location *	LS					
Category	Supplemental		GPS Latitude/Longitude							
			Start	End						
Item	DWR UCIP Field Study		38.371273 °	38.371273 °						
			-121.740138 °	-121.740138 °						
DWR ID										
Comment Code										
Inspector Comment										
FS_ID:17531 DS_ID:19355 EP_NO: 8151 Repair Type: Non-Urgent Crossing Status: Indicator Found UCIP Comments: Appears abandoned. Need to verify with pipeline owner. FIELD_STRUCT_DESC: 8-inch steel gas pipe through the levee 3 feet below the crown (Permit No. 8151, 1972). Gasline markers visible on east toe of levee at intersection of levee and Delhi road. FS Date: 8/8/2013

Gasline markers next to old rail road grade, looking south.

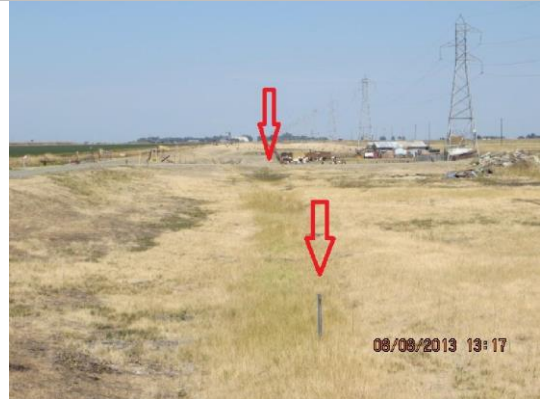
Photo 2 of 2 : UCIP_SP_2017_17531_29640.jpg

LM Start	0.91	Rating **	M	Issue No.	23 (cont)
LM End	0.91	Issue Type +	En	Location *	LS
Category	Supplemental			GPS Latitude/Longitude	
				Start	End
Item	DWR UCIP Field Study			38.371273 °	38.371273 °
				-121.740138 °	-121.740138 °
DWR ID					
Comment Code					
Inspector Comment					
FS_ID:17531 DS_ID:19355 EP_NO: 8151 Repair Type: Non-Urgent Crossing Status: Indicator Found UCIP Comments: Appears abandoned. Need to verify with pipeline owner. FIELD_STRUCT_DESC: 8-inch steel gas pipe through the levee 3 feet below the crown (Permit No. 8151, 1972). Gasline markers visible on east toe of levee at intersection of levee and Delhi road. FS Date: 8/8/2013

Gasline markers on east side of levee toe looking North.

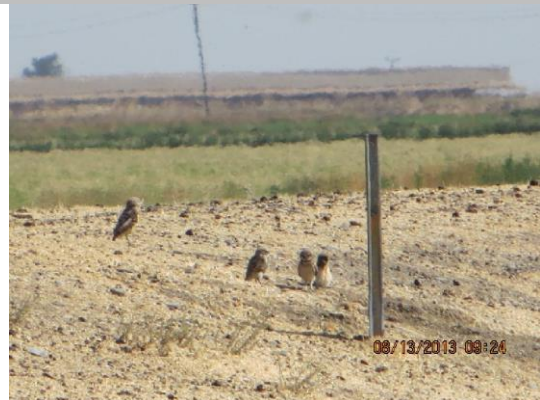
Photo 1 of 3 : UCIP_SP_2017_17532_29644.jpg

LM Start	1.07	Rating **	M	Issue No.	24
LM End	1.07	Issue Type +	En	Location *	LS
Category	Supplemental			GPS Latitude/Longitude	
				Start	End
Item	DWR UCIP Field Study			38.373330 °	38.373330 °
				-121.738530 °	-121.738530 °
DWR ID					
Comment Code					
Inspector Comment					
FS_ID:17532					
DS_ID:19354					
EP_NO: 13028					
Repair Type: Non-Urgent					
Crossing Status: Indicator Found					
UCIP Comments: Need improved signage on LS and WS shoulders.					
FIELD_STRUCT_DESC: 10-inch steel pipe through the levee 2 feet below the crown. A 4-inch gas line is sleeved through the 10-inch pipe.					
Sign missing from marker post on east slope. 2-inch vent pipe with identification sign located off west bank of levee and off toe of east side of levee at fence (Permit No. 13028, 1981).					
FS Date: 8/13/2013

Sign post without markings on WS slope.

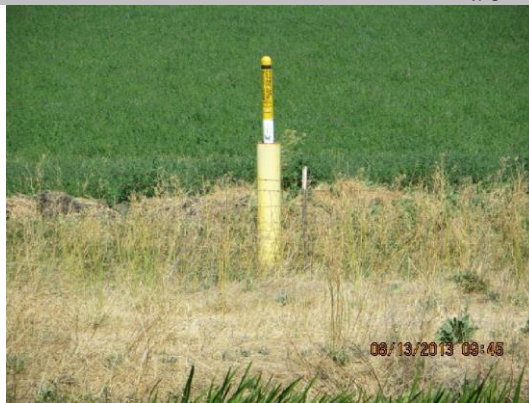
Photo 2 of 3 : UCIP_SP_2017_17532_29643.jpg

LM Start	1.07	Rating **	M	Issue No.	24 (cont)
LM End	1.07	Issue Type +	En	Location *	LS
Category	Supplemental			GPS Latitude/Longitude	
				Start	End
Item	DWR UCIP Field Study			38.373330 °	38.373330 °
				-121.738530 °	-121.738530 °
DWR ID					
Comment Code					
Inspector Comment					
FS_ID:17532					
DS_ID:19354					
EP_NO: 13028					
Repair Type: Non-Urgent					
Crossing Status: Indicator Found					
UCIP Comments: Need improved signage on LS and WS shoulders.					
FIELD_STRUCT_DESC: 10-inch steel pipe through the levee 2 feet below the crown. A 4-inch gas line is sleeved through the 10-inch pipe.					
Sign missing from marker post on east slope. 2-inch vent pipe with identification sign located off west bank of levee and off toe of east side of levee at fence (Permit No. 13028, 1981).					
FS Date: 8/13/2013

Sign marker off LS toe.

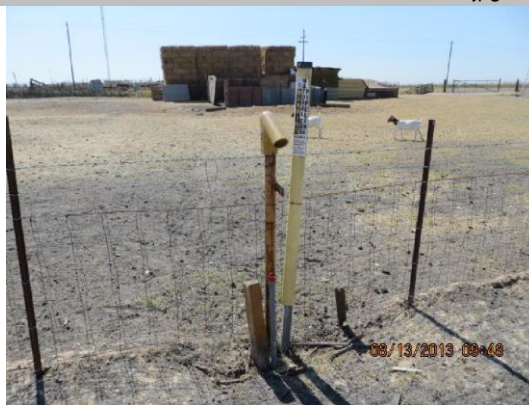
Photo 3 of 3 : UCIP_SP_2017_17532_29642.jpg

Vent and signage off WS toe.

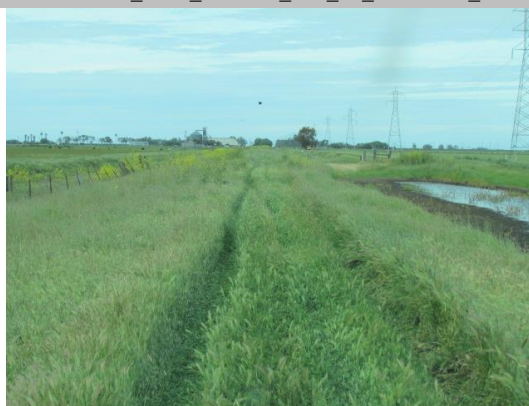
Photo 1 of 2 : SP_2017_RD2068_194_15_20170518_00013.jpg

Looking downstream from levee mile 2.16

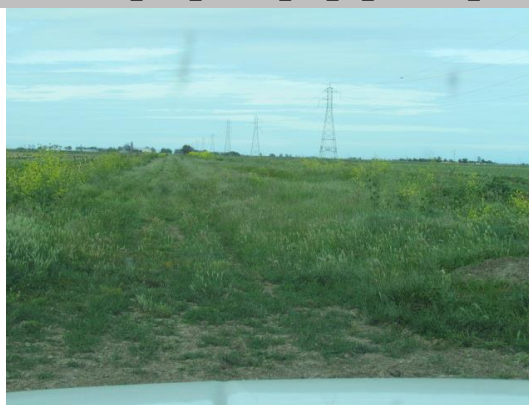
Photo 2 of 2 : SP_2017_RD2068_194_15_20170518_00014.jpg

LM Start	1.85	Rating **	U	Issue No.	15 (cont)
LM End	2.16	Issue Type +	Ma	Location *	CR

Looking upstream from levee mile 2.16.

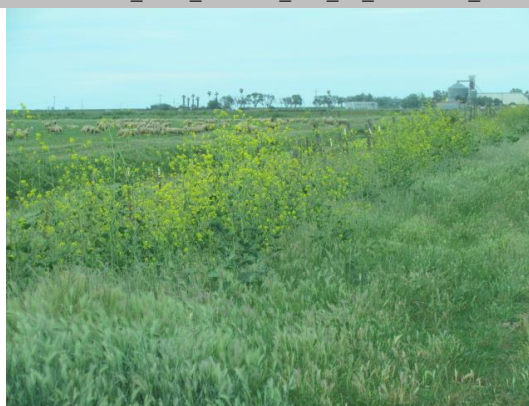
Photo 1 of 1 : SP_2017_RD2068_194_16_20170518_00011.jpg

LM Start	1.85	Rating **	U	Issue No.	16
LM End	2.16	Issue Type +	Ma	Location *	LS
Category	Earthen Levee			GPS Latitude/Longitude	
				Start	End
Item	Vegetation			38.382542 °	38.386237 °
				-121.730262 °	-121.726930 °
DWR ID	DWR_RD2068_02_s_2017_16				
Comment Code					
V1 : Control annual grass and weeds on the levee slopes and easements.					
Inspector Comment					
Control the annual grasses and weeds on the landside slope and toe.

RD 2068 landside slope levee mile 1.85- 2.16.

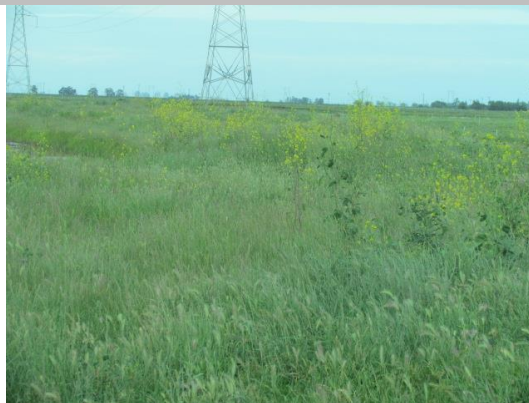
Photo 1 of 1 : SP_2017_RD2068_194_17_20170518_00012.jpg

RD 2068 Waterside levee mile 1.85-2.18
